Study of the Regenerated Layer on the Worn Surface of a Cylinder Liner Lubricated by a Novel Silicate Additive in Lubricating Oil

WEN YUE,¹ CHENGBIAO WANG,¹ YUANDONG LIU,¹ HAIPENG HUANG,² QINGFENG WEN,³ and JIAJUN LIU⁴

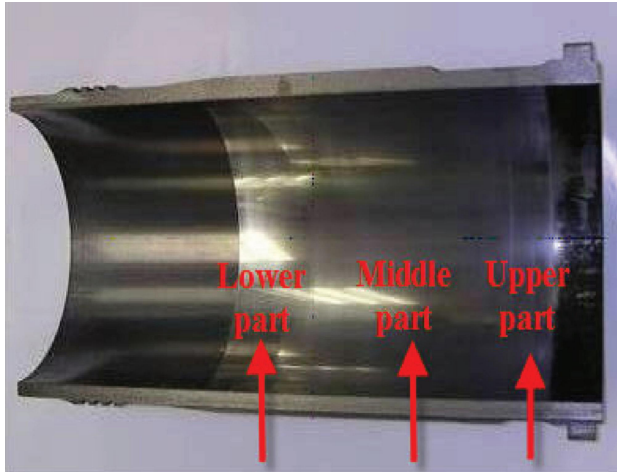
Fig. 1—Photo of the practical worn chrome-plated cylinder liner.

A chromium-plated cast iron cylinder liner from the internal-combustion engine of a locomotive after running 260,000 km under the lubrication with the silicate additive was analyzed. The picture of its outward appearance is shown in Fig. 1. It can be clearly seen that the surface of the cylinder liner has become very smooth, like a mirror, and it seems to be coated by a thin and transparent film, while the original wear tracks, especially at the upper and lower dead positions, are still visible but cannot be felt by touching.

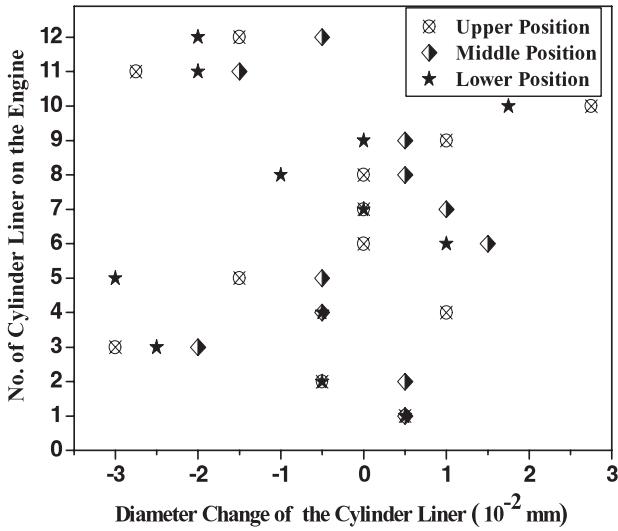
The diameter at three different locations of 12 cylinder liners on the engine was measured with an inside micrometer before and after the test of lubricating oil containing silicate additive. The results are shown in Fig. 3. It can be found that, in general, the wear of cylinder liners was maintained at almost zero-wear level on average; some data were even negative, which indicates that a repaired layer (or regenerated layer) was probably formed on the worn surface. These phenomena were quite apparent at the upper position, which indicates that the effects of the silicate additive are uneven on different locations of the cylinder liner.

Fig. 3—Diameter change of three different locations of twelve cylinder liners on the engine after test.

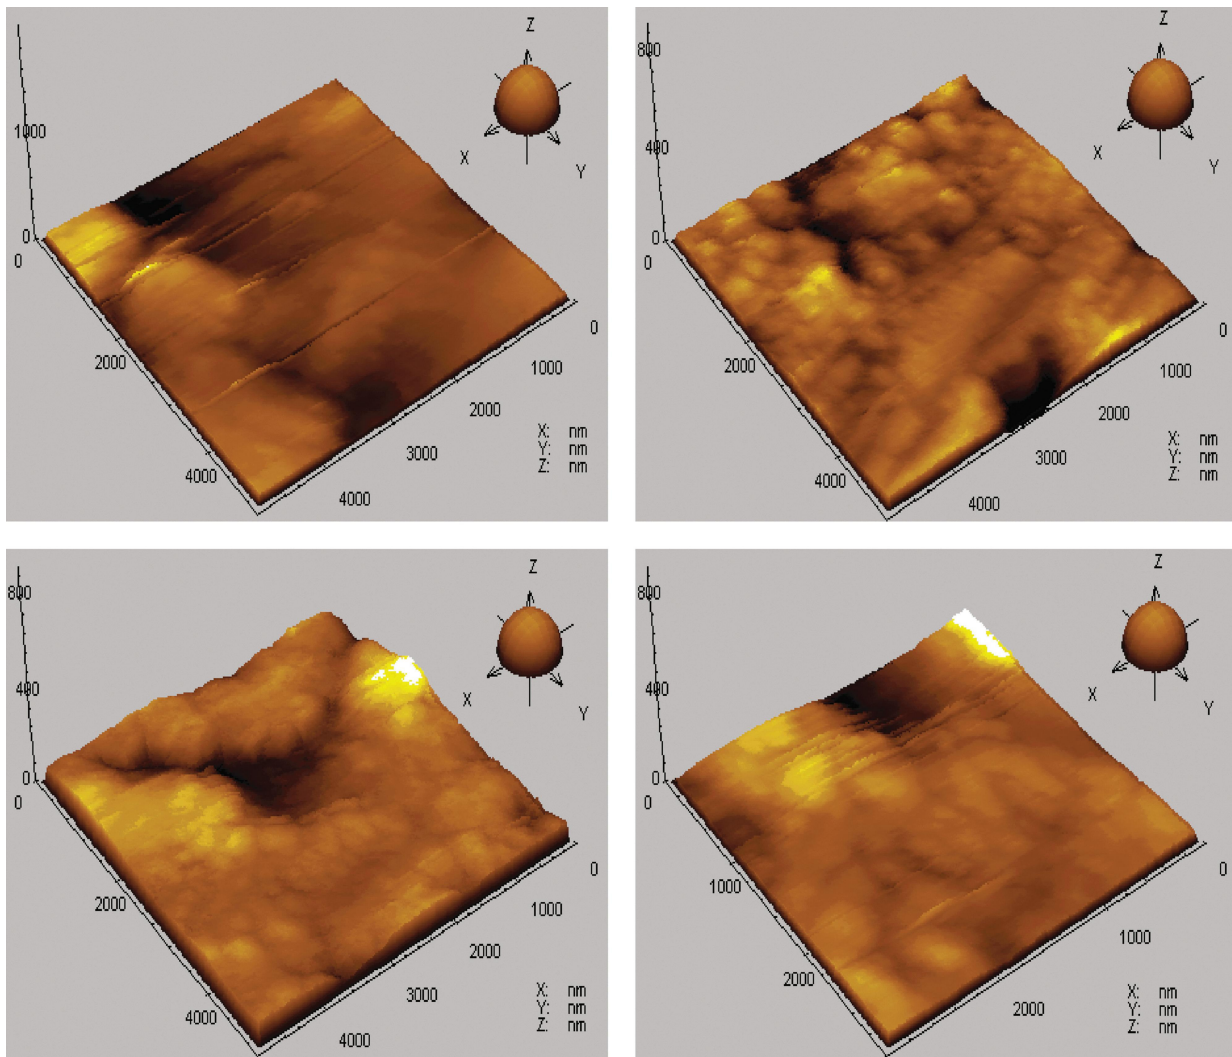
The original surface roughness Ra of the cylinder liner is about 1 μm, whereas that of four different locations of the worn surface roughness became Ra = 36.9, 47.1, 112.5, and 31.0 nm, respectively. The measurement results by AFM are shown in Fig. 4. It can be considered that the surface roughness was significantly reduced in the friction and wear process.

Fig. 4—Morphology of friction surfaces of the cylinder liner.

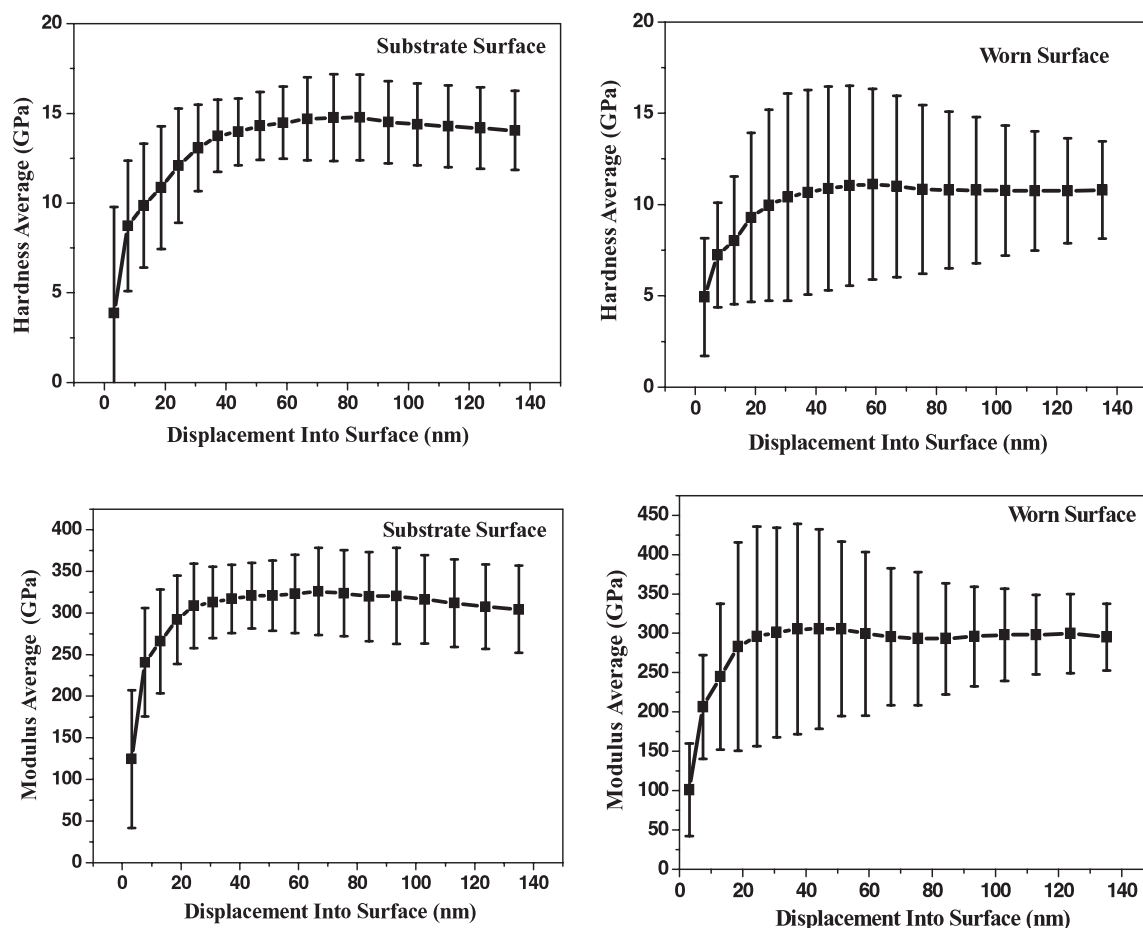
The average results of nanohardness and modulus at five different locations on the worn surface are shown in Fig. 5. The indentation depth of the conventional microhardness tester was more than 2 μm, much larger than the thickness of the repaired layer. The microhardness data must be influenced by the substrate. So it is necessary to measure the nanohardness of the repaired layer. The depth of indentation in the nanohardness test was 150 nm, which can reflect the true hardness of the repaired layer. The chromium-plated cylinder liner’s hardness of the worn surface became a little lower than that of the substrate surface, but it was still above 10 GPa. It should be mentioned that the nanohardness and modulus data of the worn surface were more scattered than that of the substrate surface, which indicated that

Fig. 5—Nanohardness and modulus comparison of the substrate and the worn surface.

the effect of the silicate additive possessed certain selectivity at different locations of the worn surface.

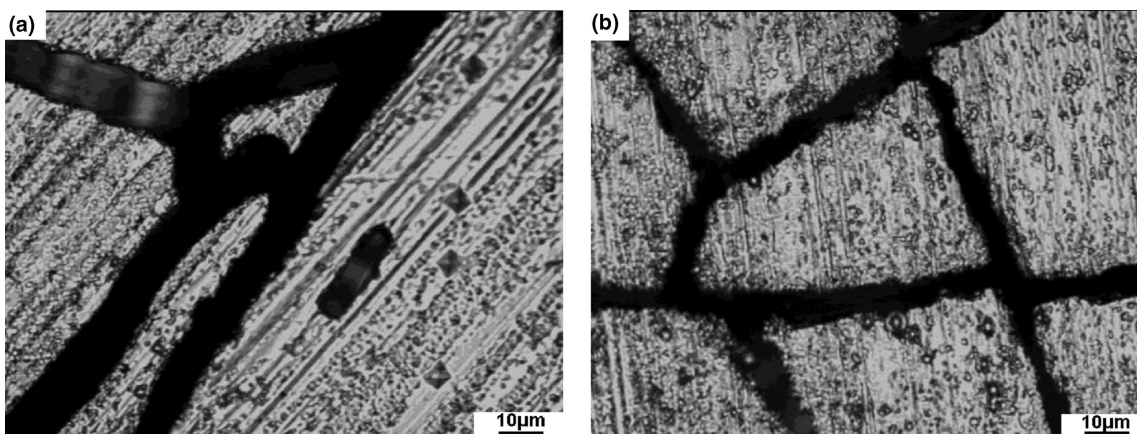
can be seen clearly that some reticular cracks were present on the substrate surface and worn surface of chrome-plated layer under optical microscope (see Figs. 6(a) and 6(b)), and the cracks were still found on the substrate surface under SEM (see Figs. 7(a) and 7(b)); however, on the worn surface they basically disappeared under SEM (see Fig. 7(c) and 7(d)). This phenomenon indicated

Fig. 6—Optical morphologies of substrate and worn surface on chromium-plated cylinder liner: (a) substrate surface, (b) worn surface.

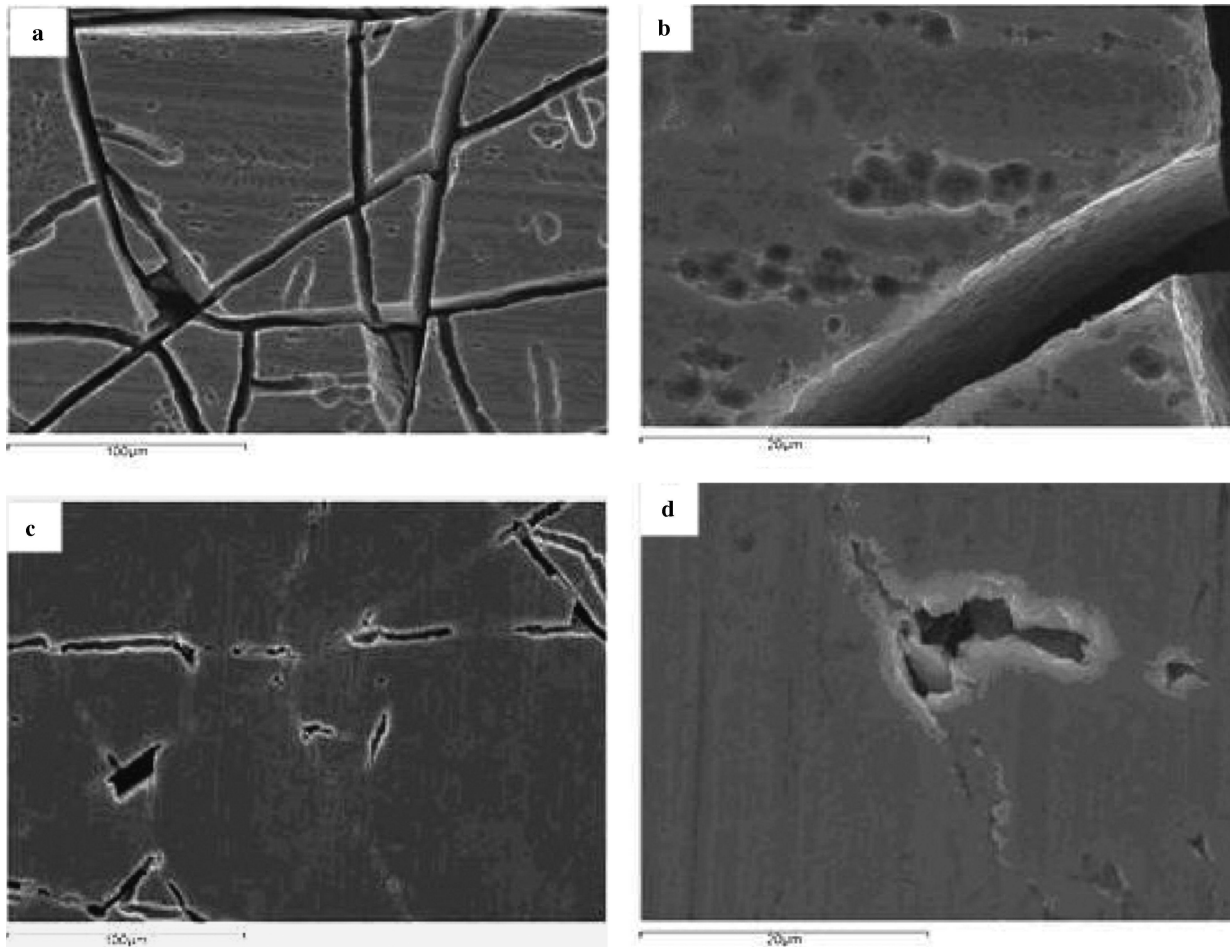
Fig. 7—SEM morphologies of substrate and worn surface on chrome-plated cylinder liner: (a), (b) substrate surface; (c), (d) worn surface.

that the worn surface was covered indeed by a thin transparent film due to different principles of image formation under SEM. The electron beam of SEM was acting only with the top surface of the sample, and the observed morphology reflected just the thin transparent film, while the optical microscope could observe the original cracks through the transparent film because of the higher transmission power of the visible light.

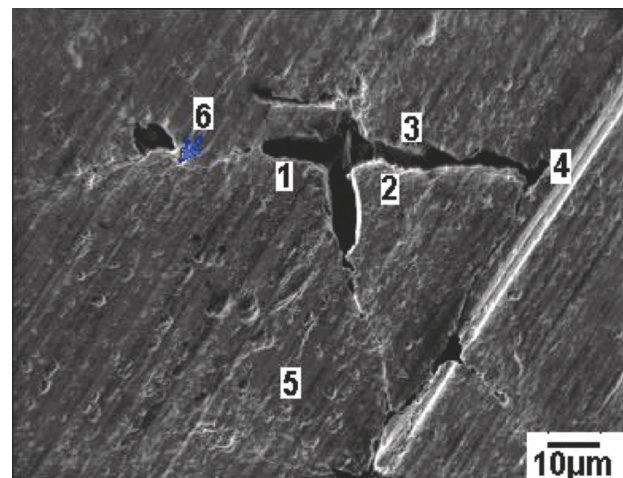
A translucent repaired layer was suggested to be formed on the worn surface; therefore, the accurate composition of this layer should be analyzed by AES. Six points on the worn surface were selected to do AES tests as shown in Fig. 8. Points 1, 2, and 3 were on the edge of cracks; point 4 was on the end edge of the cracks; point 5 was on the flat area; point 6 was on a pitting area. The full Auger spectra of six points showed that the chromium peak

Fig. 8—SEM morphologies at the AES tested points.

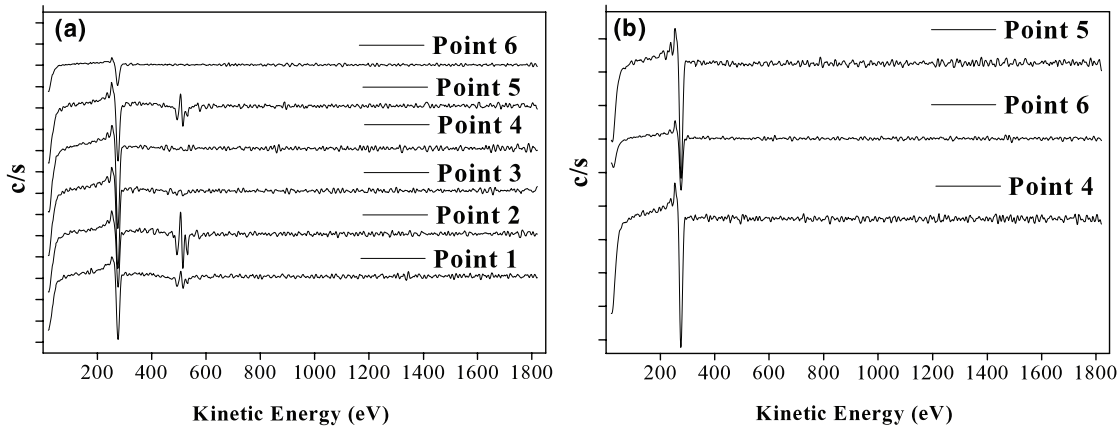
Fig. 9—Full auger spectra of the worn surface: (a) the top surface; (b) sputtered 3.6 nm.

and carbon peak were found on points 1, 2, and 5, and only the carbon peaks were found on points 3, 4, and 6. However, only the carbon peak appeared on all six points after sputtering 3.6 nm as shown in Fig. 9. This means that the top of the worn surface was composed of a little chromium and a lot of carbon.

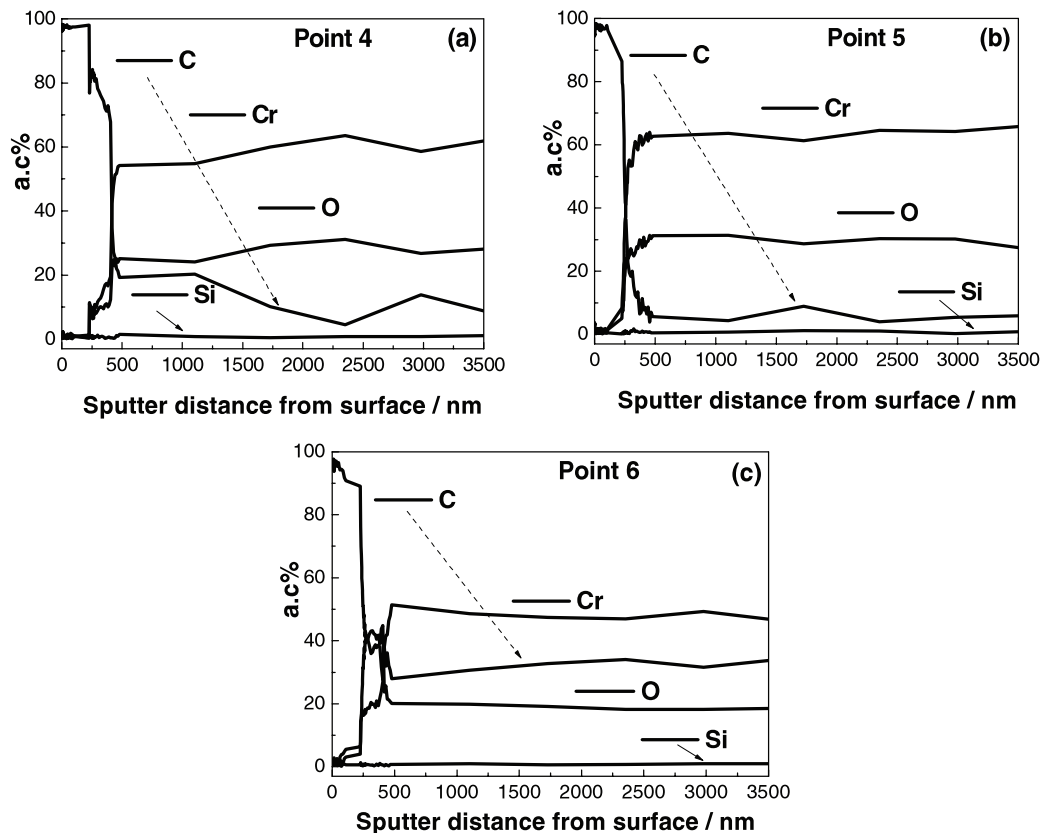
Only the carbon, oxygen, and chromium elements were found on the worn surface, which were corresponding to the above EDS analysis results. At the top surface, carbon content was very high; then it decreased with the sputtering depth; the thickness of the carbon-rich repaired layer was uneven it was about 250 nm on the flat area and about 400 nm at the end edge of cracks. Nevertheless, the curves of three elements on the pitting area were

Fig. 10—Variations of chromium-plated cylinder liner's element contents with the sputtering depth: (a) point 4; (b) point 5; (c) point 6.

different from those of the flat area and cracks, which indicated that the microcracks of pitting were covered by the transparent repaired layer. This was why the cracks disappeared under SEM observation.

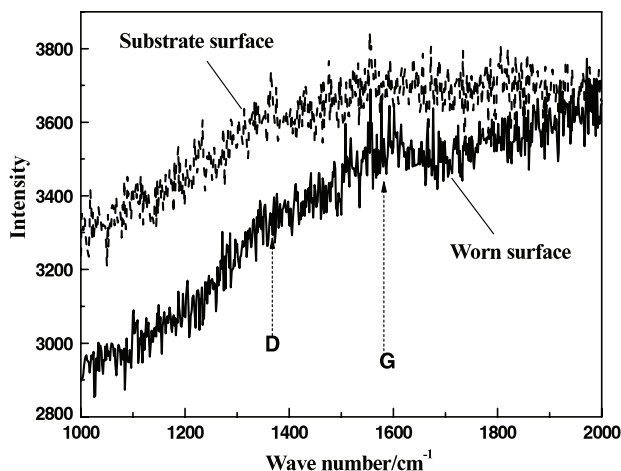
Fig. 11—Raman spectra of the substrate surface and worn surface.

The carbon structure of the repaired layer was analyzed by Raman spectroscopy and is shown in Fig. 11. Specific peaks D and G were found on the worn surface, but the intensity of them was relatively weak, whereas nothing was found on the substrate surface. Peak D represents amorphous carbon structure, and Peak G represents graphite structure. Therefore, the most likely structure of the carbon-rich layer was considered to be amorphous carbon structure, including some microcrystalline graphite.
