Study of the Regenerated Layer on the Worn Surface of a Cylinder Liner Lubricated by a Novel Silicate Additive in Lubricating Oil

WEN YUE,¹ CHENGBIAO WANG,¹ YUANDONG LIU,¹ HAIPENG HUANG,² QINGFENG WEN,³ and JIAJUN LIU⁴

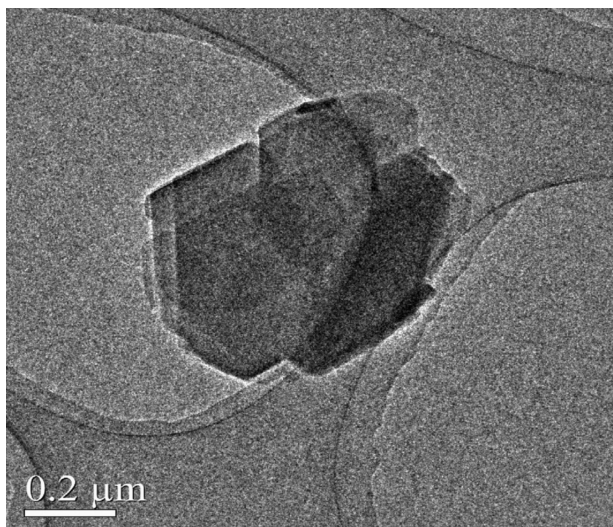
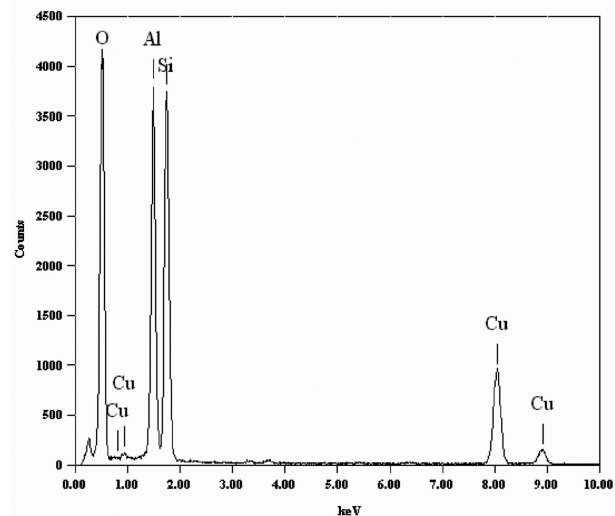
Fig. 2—TEM morphology and energy spectrum analysis of the mineral particle.

The silicate additive is composed of silicate powders prepared from natural minerals and some dispersants (Nikolaevich, et al. (13)). The granularity of the silicate powder ranges from 1 to 5 μm . The silicate particles exhibit a thin layer of hexagonal structure, the plane size is less than 1 μm , and the longitudinal size ranges from 20 to 40 nm. It contains Al, Si, and O elements, as shown in Fig. 2. The crystal structure was determined by its diffraction pattern, and then the formula of the mineral was determined to be $\text{Al}_4[\text{Si}_4\text{O}_{10}](\text{OH})_4$. The additive was added to the engine lubricating oil of the locomotive at a concentration of 6 wt%.
